# 2010

## FIFA World Cup

Athlone Stadium

Environmental performance enhanced

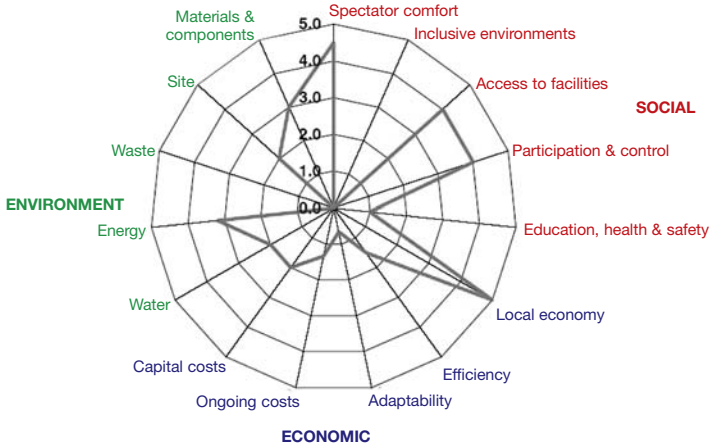
In terms of the SBAT, the performance of Athlone Stadium was measured in relation to social, economic and environmental criteria. In certain aspects, the sustainability performance of the stadium was found to be good (especially in terms of local economy and spectator comfort). However, as would be expected of an existing and already established stadium, the sustainability performance was unbalanced with lower scores awarded in terms of adaptability, waste management and the establishment of an inclusive environment.

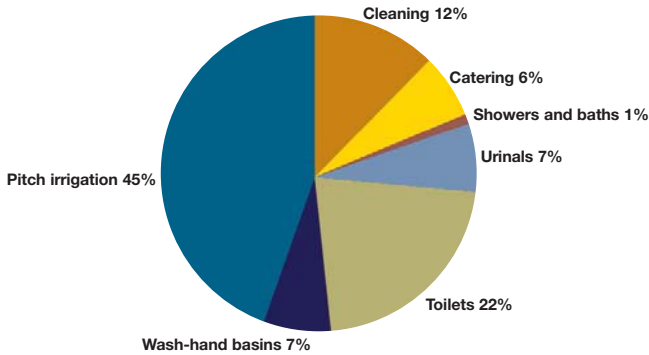
### Water consumption baseline

Pitch irrigation	10 530 m <sup>3</sup> /year	44,66%
Wash-hand basins	1 656 m <sup>3</sup> /year	7,02%
Toilets	5 154 m <sup>3</sup> /year	21,86%
Urinals	1 615 m <sup>3</sup> /year	6,85%
Showers and baths	225 m <sup>3</sup> /year	0,96%
Catering	1 500 m <sup>3</sup> /year	6,36%
External landscaping	0 m <sup>3</sup> /year	0,00%
Cleaning	2 900 m <sup>3</sup> /year	12,30%
<b>Total water consumption</b>	<b>23 580 m<sup>3</sup>/year</b>	<b>100,00%</b>

In the case of Athlone Stadium, pitch irrigation accounts for 45% of total water use, the toilets 22% and cleaning 12%.

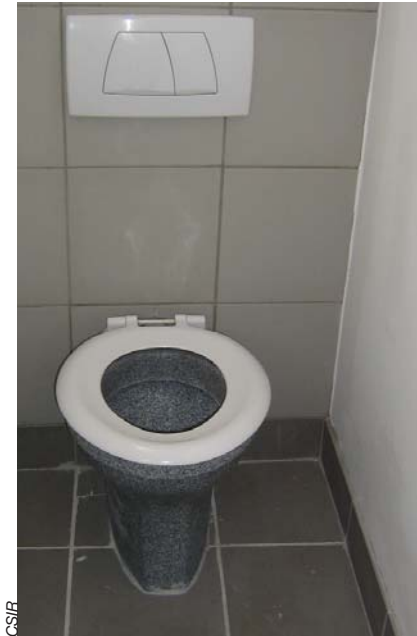
Dual-flush toilets help reduce water consumption at Athlone Stadium.

- Dual-flush toilets for VIP facilities**  
 Water consumption is reduced during sporting events
- Self-closing metering valves**  
 Additional water savings are achieved during sporting events
- Low-flow shower heads**  
 Fitting of all showers with low-flow heads (10 l/minute) and flow regulators (9 l/minute) results in a further reduction of potable water consumption during events.

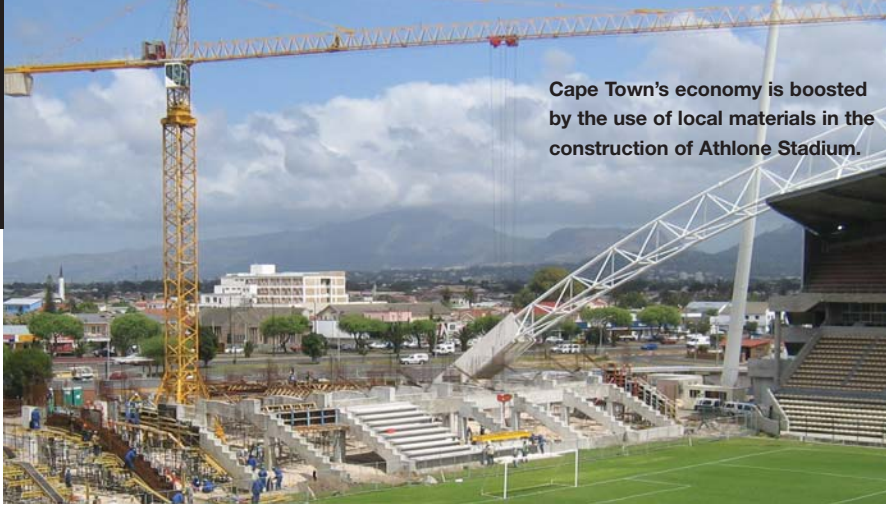
Cape Town's economy is boosted by the use of local materials in the construction of Athlone Stadium.

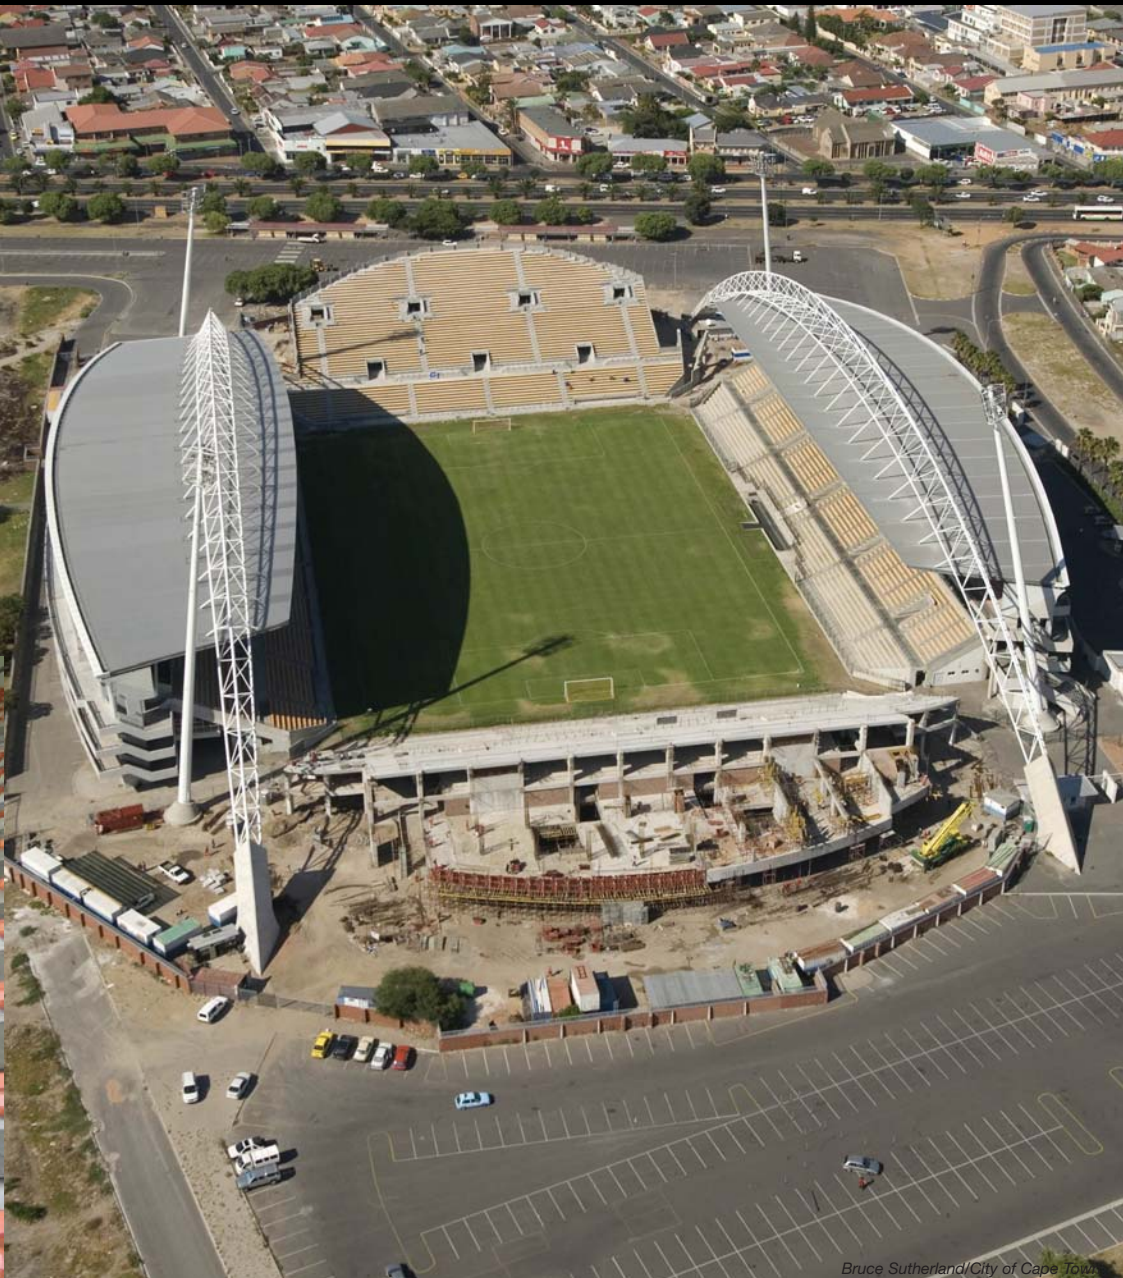
**The fruits of the labour are becoming visible.  
By March 2009, the first of the additional stands had  
been completed.**
